(NASA-TM-75351) COMPOSITE COMPONENTS UNDER
IMPACT LOAD AND EFFECTS OF DEFECTS ON THE
LOADING CAPACITY (National Aeronautics and
Space Administration) 47 p HC A03/MF A01

COMPOSITE COMPONENTS UNDER IMPACT LOAD AND EFFECTS
OF DEFECTS ON THE LOADING CAPACITY

Contents:	Page
Part A: Dipl. Ing. D. Wurzel Composite Components Under Impact Load	4
Part B: Dipl. Ing. R. Aoki Effects of Defects on the Loading Capacity of Composite Materials	17

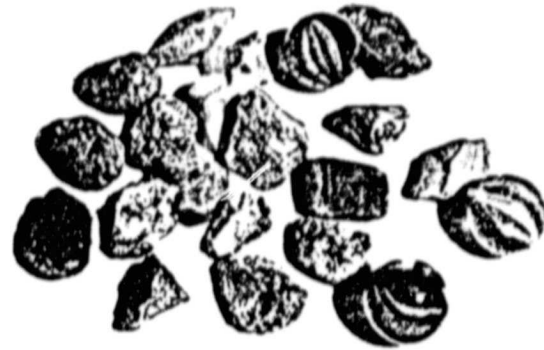
Stone Projectiles for
Simulation of Stone
Damage

Experimental
Nose-Section with
Damage after
Bombardment with
Glass Bullets and Stones

Damage on the Side of the Nose
(Vicotex 1452) by impact of
a Screwdriver from a Height
of 1.8 m with a mass of 113 g

Fig. 7. Impact tests on fiber composite--noses.

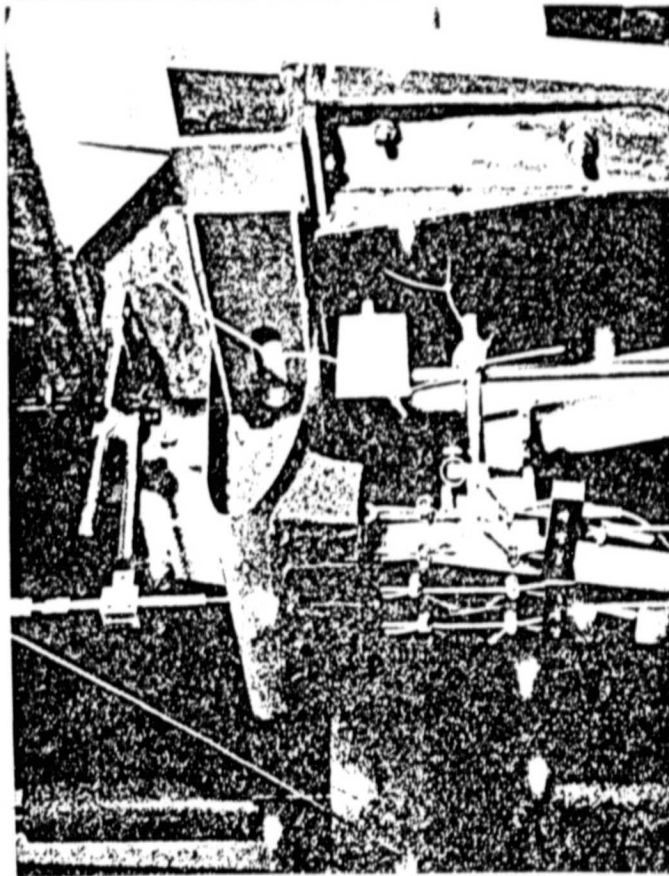
Luftlastbiegung
Air pressure Bending

Torsion / Biegung
Torsion / Bending

Fig. 8. Experimental arrangement.
